Report No. CG-D-40-77

RECREATIONAL BOAT SAFETY
COLLISION RESEARCH:
COLLISION ACCIDENT INVESTIGATIONS
JULY 1976 - DEC 1976

JANUARY 1977

FINAL REPORT

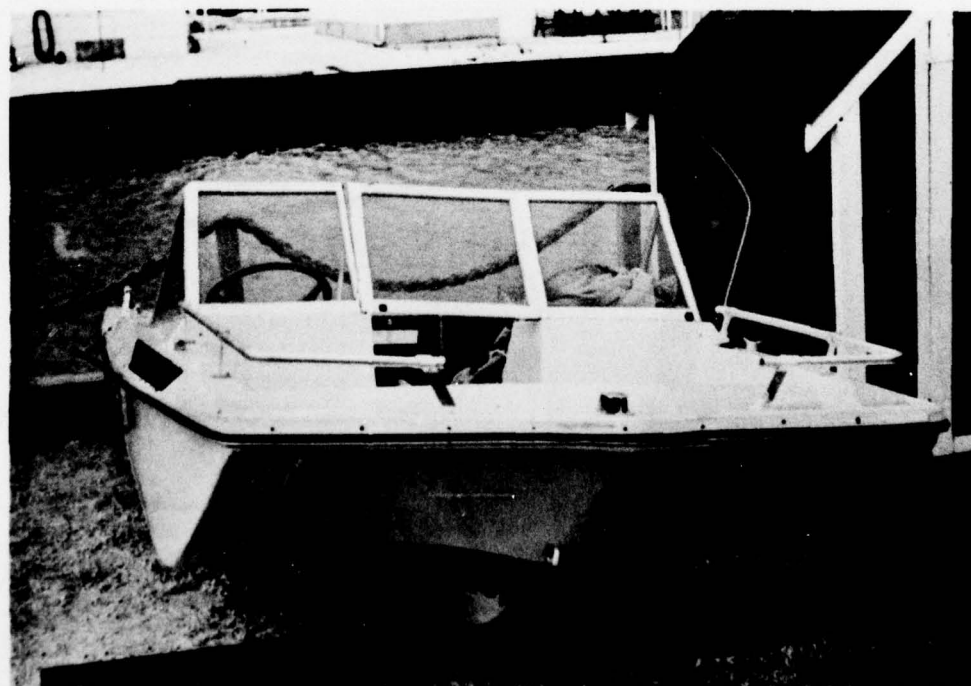
FIGURE 8. 14' (4.3 M) RUNABOUT. NOTE OPEN RIVET HOLES ABOVE RUB RAIL WHERE DECK POPPED LOOSE

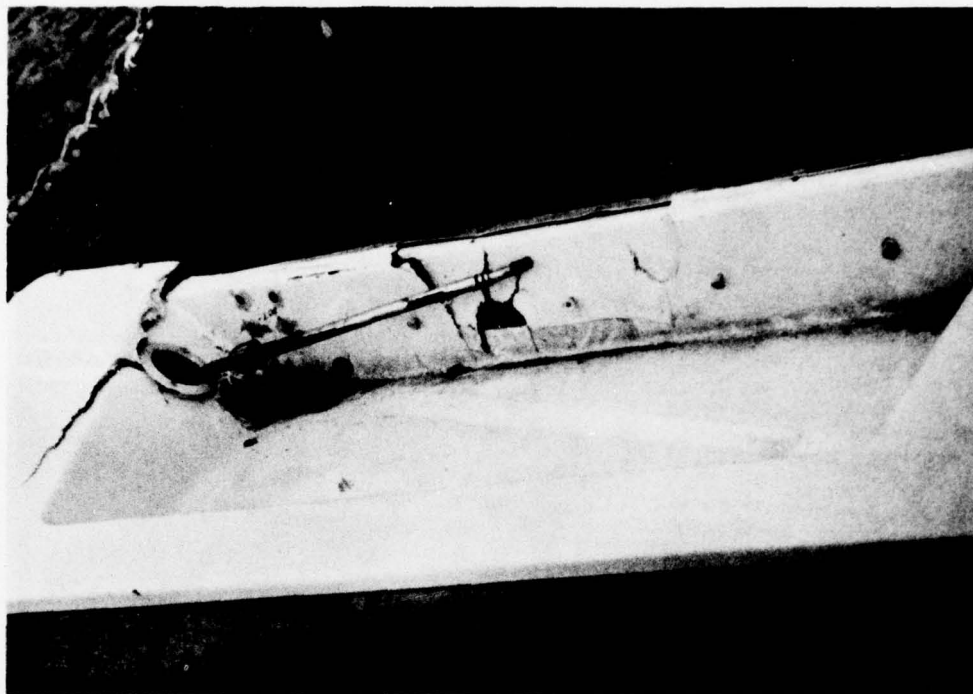
FIGURE 11. 14' (4.3 M) RUNABOUT. DETAIL OF MOTOR WELL, TRANSOM AND STEERING CONTROL DAMAGE

The runabout's steering was affected as the sleeve and control cable were displaced to port by the impact. It would probably have been necessary to disconnect the steering gear and turn the motor by hand if the runabout needed to travel any distance to reach safety.

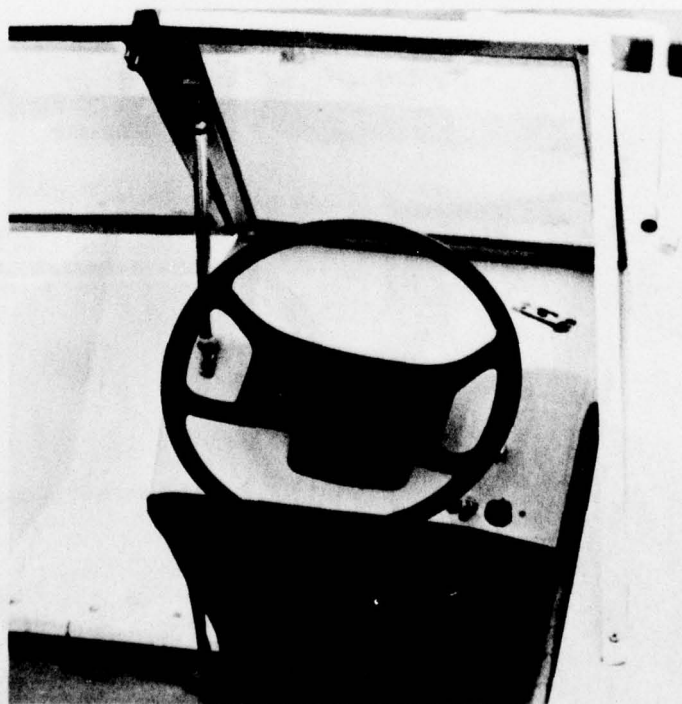
FIGURE 12. 14' (4.3 M) RUNABOUT CONTROL STATION. NOTE SHARP WINDSHIELD EDGES AND CORNERS

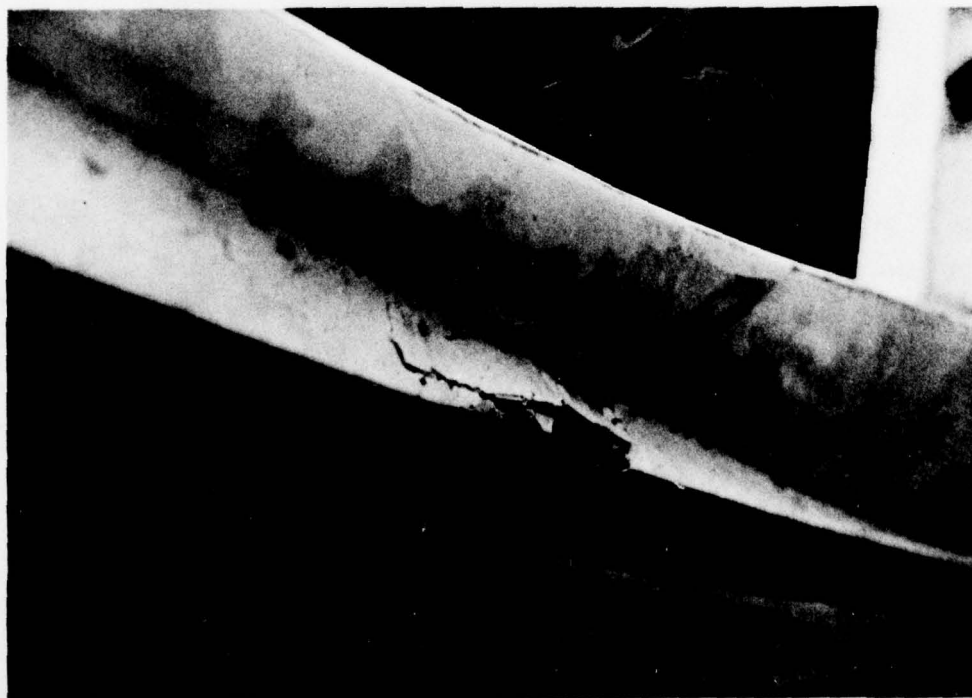
FIGURE 8. GUNWALE DAMAGE

The port coaming was crushed in a six inch (15.2 cm) area where the stem of the cabin boat impacted it. Scratches and bottom paint from the cabin boat were evident where the three separate hulls contacted the coaming and the engine. The port seat had been knocked loose and the engine mount was twisted slightly. The gel coat was cracked for about four feet (1.2 m)

under and outboard of the coaming where the fiberglass structure had bent. No structural damage could be found in that area. In fact, the only apparent structural damage was a bent aluminum gunwale guard rail and the six inch (15.2 cm) portion of crushed coaming mentioned above.

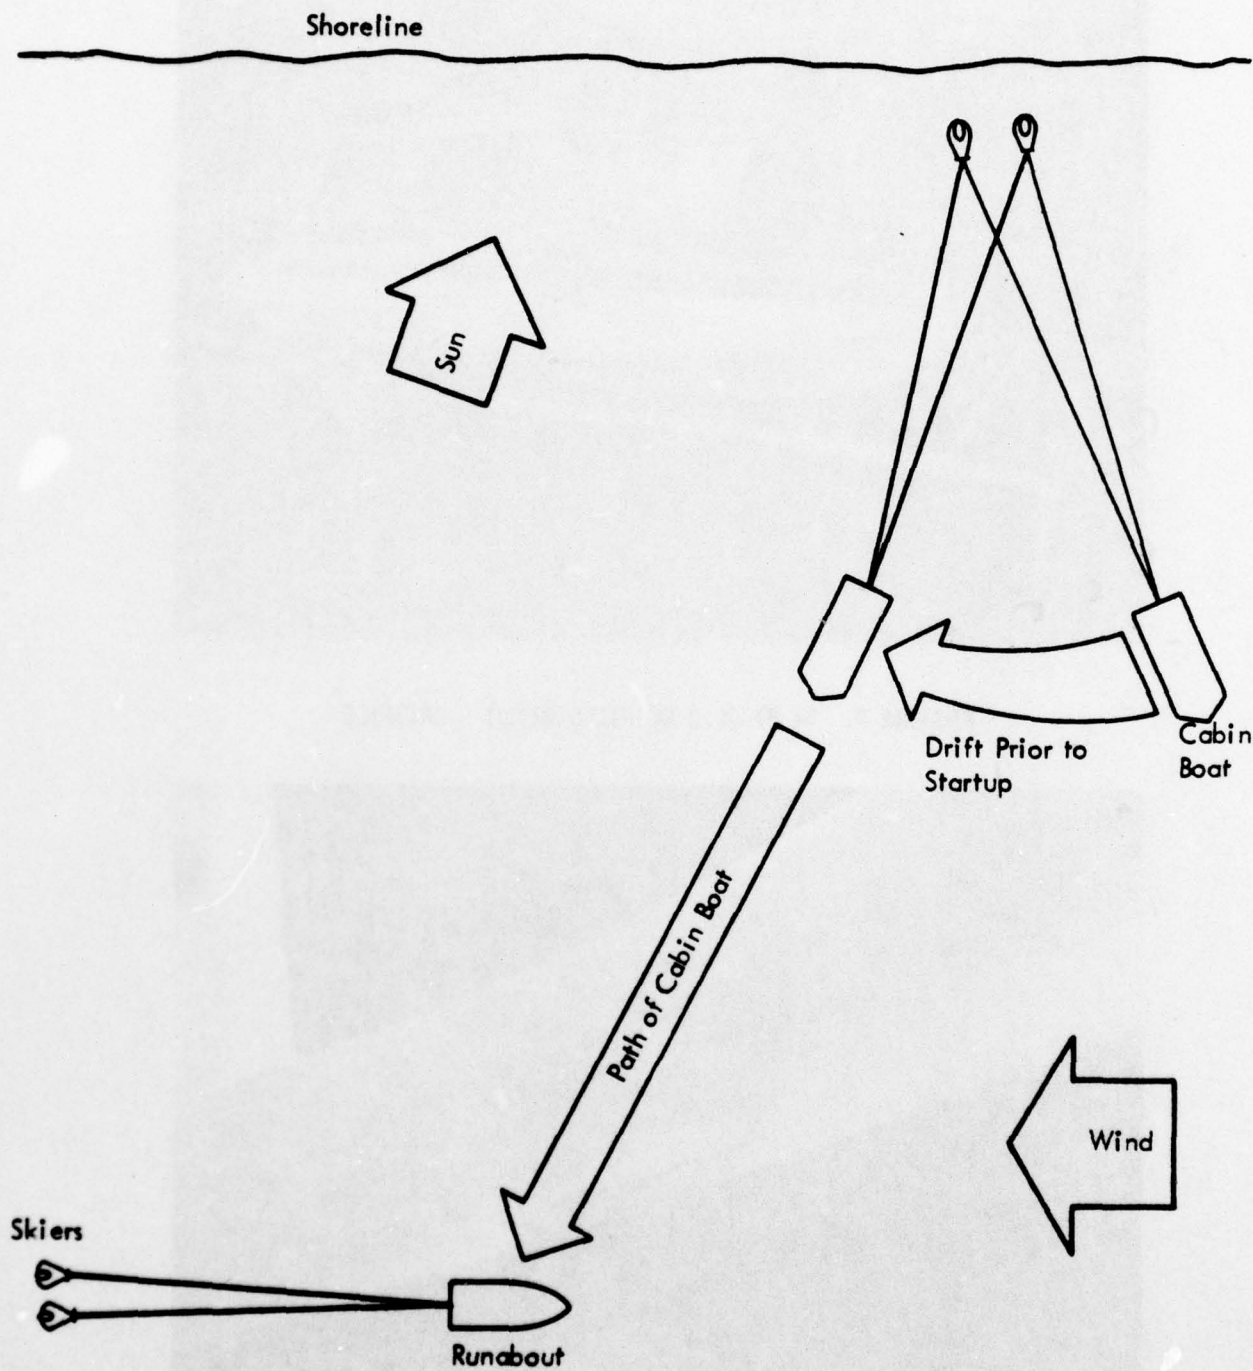
FIGURE 9. COLLISION AREA

The runabout was struck broadside (see Figure 9) by the lower portion of the stem of the cabin boat. As the cabin boat slid up and over the runabout, it pushed the port corner of the runabout underwater causing it to swamp. That, coupled with the fact that the runabout had a double wall construction in the lower portion of the hull sides, was the reason that the runabout sustained relatively little damage.

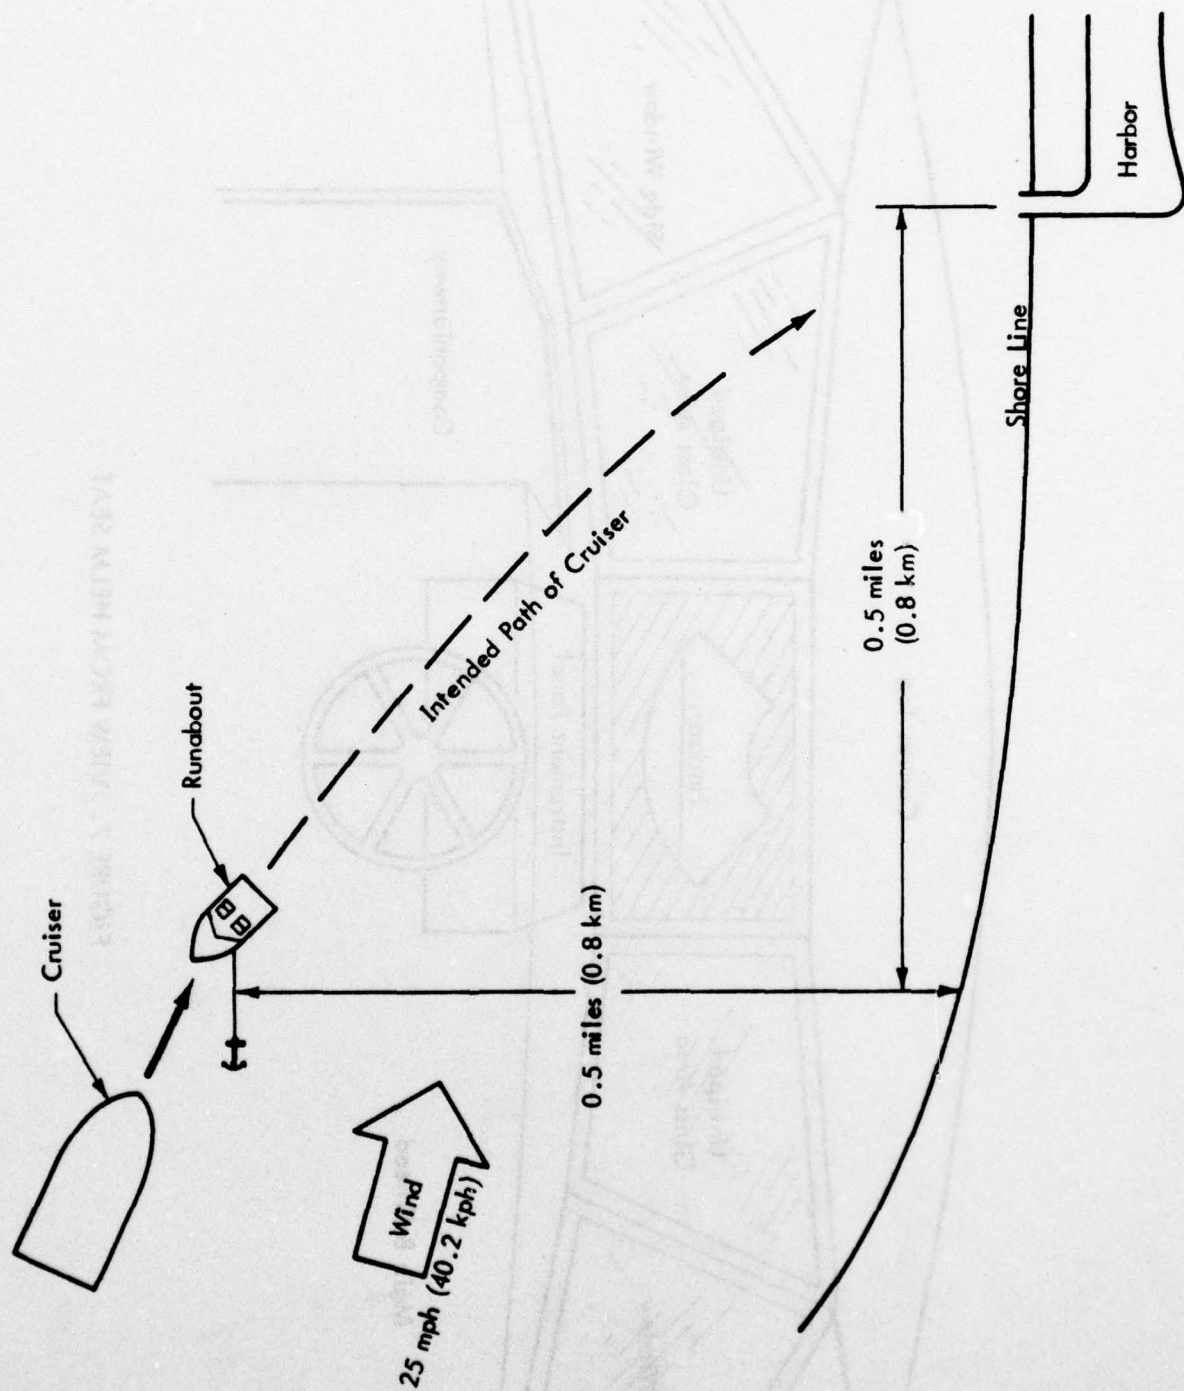
FIGURE 8. COLLISION AREA DIAGRAM

The cruiser hit the runabout about one foot (0.3 m) to port of the center of the bow from almost head on. The runabout was anchored from a point close to the port corner of the windshield. The impact caused the runabout's bow to sink and the stern to rise. The runabout was pushed sideways for some distance until the anchor line stretched to the point that it caused the runabout to rotate clockwise. The cruiser then continued through the bow of the runabout at approximately right angles to the centerline from left to right. (See collision area diagram, Figure 8.)

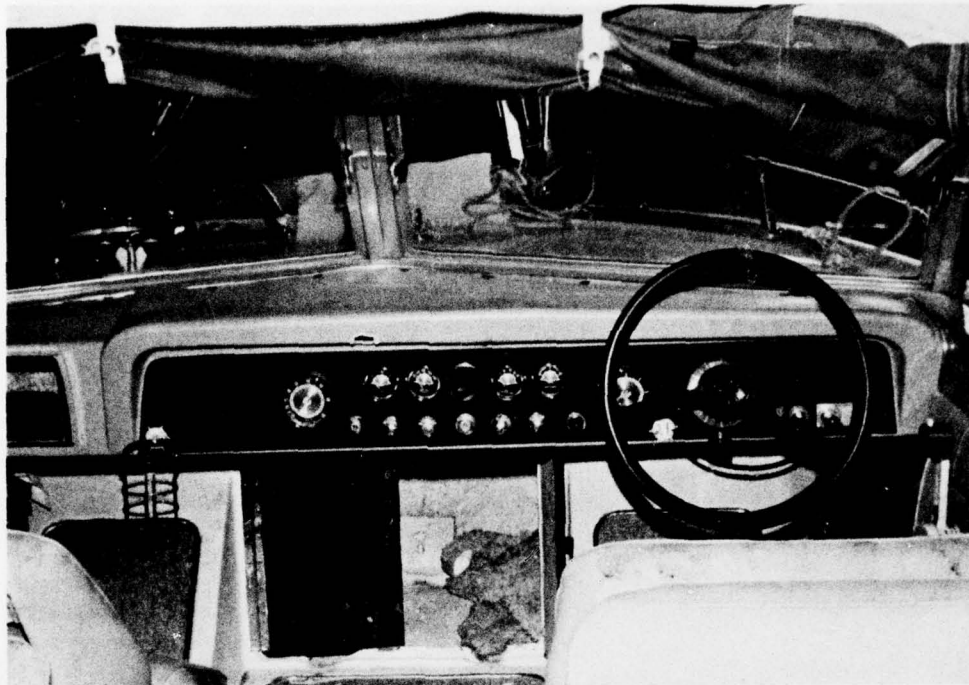
FIGURE 7. DAMAGE TO INSTRUMENT PANEL

The operator was steering with his right hand when the boat suddenly turned to starboard. He did not have time to grab the wheel with his left hand and retard the throttle with his right hand before impact with the pier. The boat impacted the pier bow on. There was visual evidence that the operator was thrown forward into the approximate center of the instrument panel.

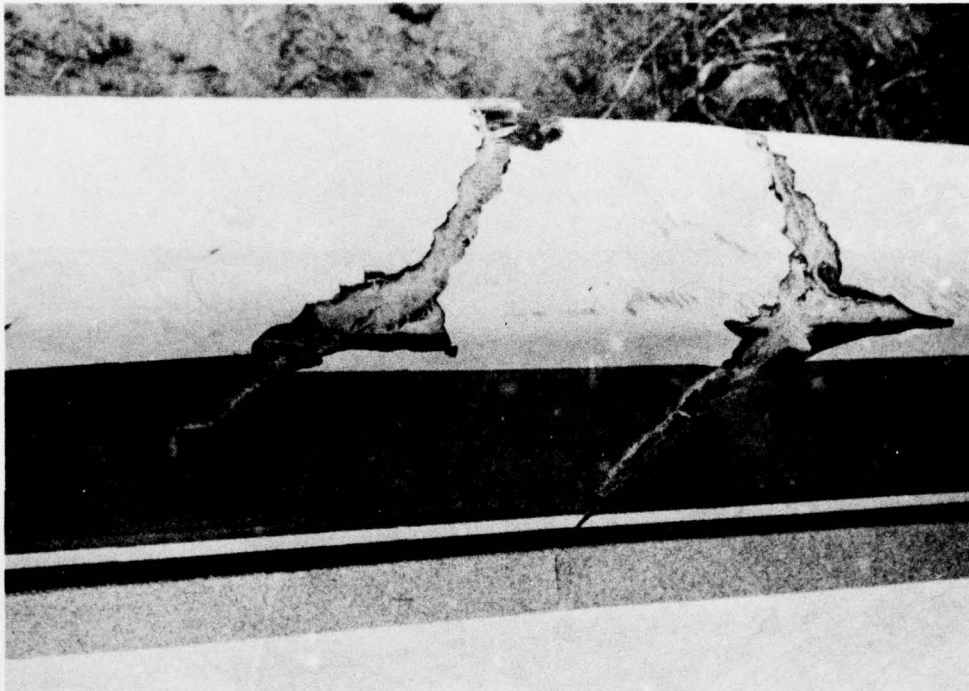
FIGURE 4. BOAT NO. 1 - DAMAGE ON PORT COAMING CAUSED BY BOW OF BOAT NO. 2

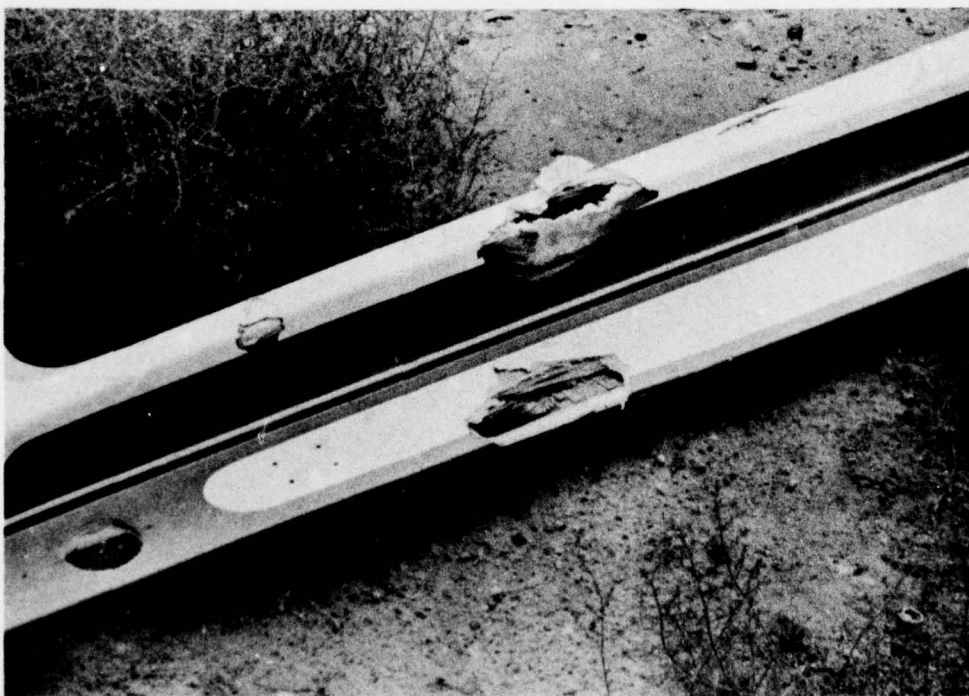
FIGURE 5. BOAT NO. 1 - DAMAGE ON STARBOARD COAMING CAUSED BY PROPELLER OF BOAT NO. 2

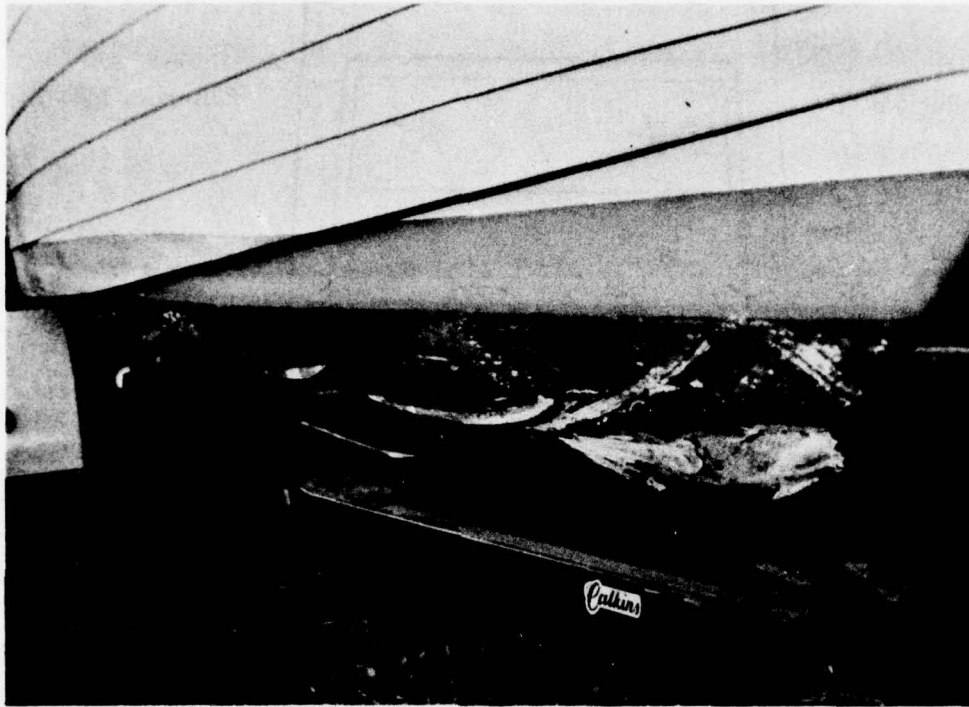
FIGURE 3. DAMAGED FOREFOOT

Because the boat was operating at a bow high attitude, the forefoot was at such an angle that it enabled the boat to slide up onto the breakwall. Thus, much of the energy was absorbed by the friction of the starboard portion of the bottom of the boat as it rode up onto the breakwall. Had the boat been going slower, it would have been running at a flatter angle. The stem may have been crushed, thus opening a larger hole for water to enter. If the boat had been going faster, it would also have been running flatter with the same results.

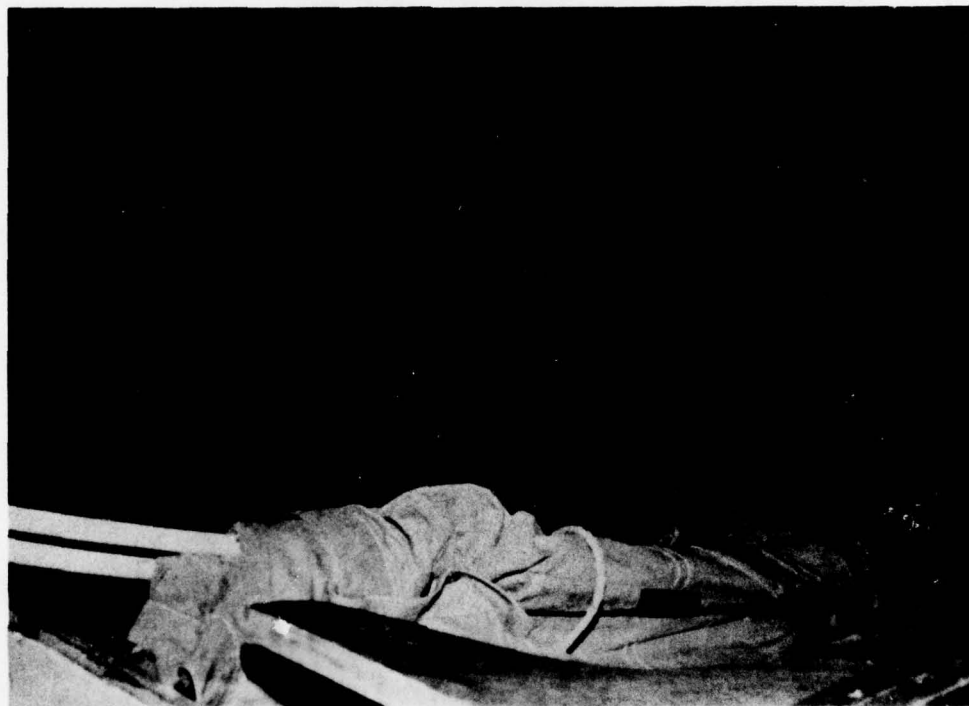
FIGURE 4. STRUCTURAL DAMAGE TO STARBOARD SIDE

The bow of Boat No. 2 impacted the starboard side of Boat No. 1 near amidships and essentially perpendicular to the longitudinal axis. The impact ripped a large section out of the starboard side of Boat No. 1. The forward momentum of Boat No. 2 carried it across Boat No. 1 and into the water on the port side. As Boat No. 2 traversed across Boat No. 1, its weight pushed No. 1 down, causing it to begin flooding immediately. The bow of Boat No. 2 raised after impact, causing it to jump over Boat No. 1 as was evident from the minimal damage to the port side of Boat No. 1. Apparently, Boat No. 1 was pushed under water or sank immediately because the occupants of Boat No. 2 did not see it within seconds after the collision. Within a short time after sinking, Boat No. 1 rolled upside down and the bow section resurfaced.
